**BLUECOAT
Conservation
Plan**

Donald Insall Associates

March 2002

**THE BLUECOAT ARTS CENTRE
CONSERVATION PLAN**

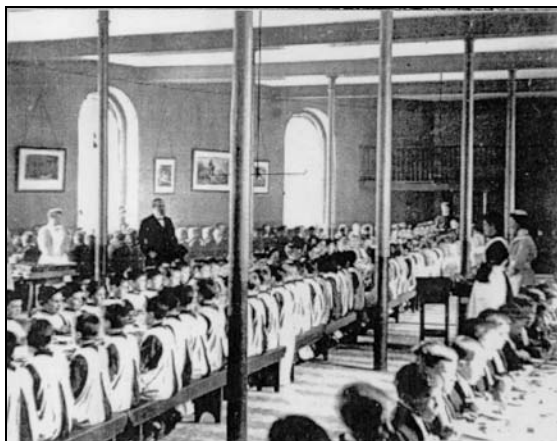
*The School Dining Hall
Ground Floor Central Block
(19th century)*

On going through the centre doorway of the main building one would have found that the ground floor was not divided up into small rooms as now but was one large room with cast iron columns supporting the floor above. It had been the main dining room and at each end were galleries from which visitors had watched the children at meals.

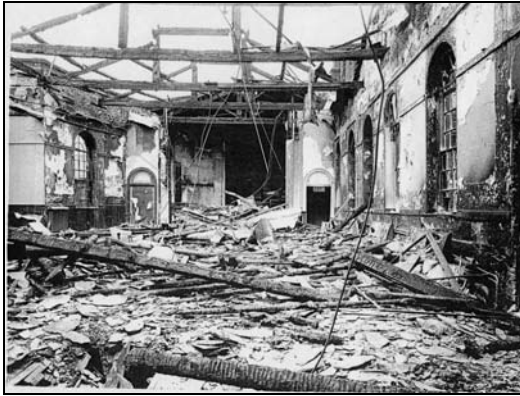
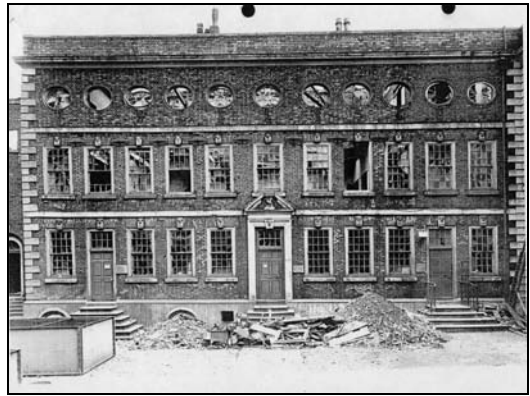
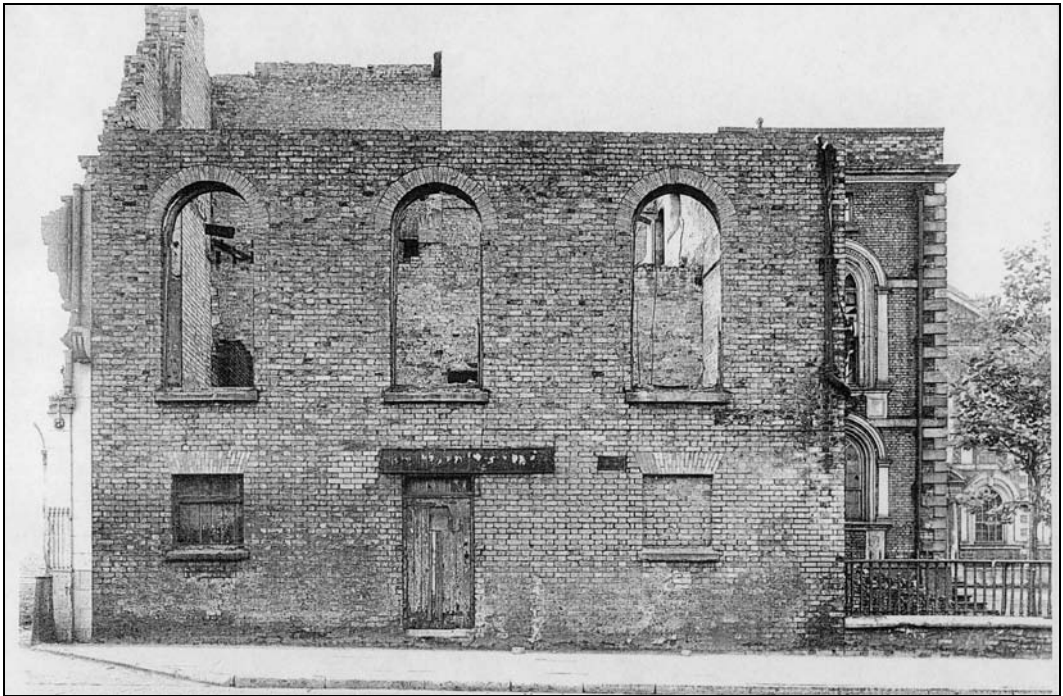
Fire and bomb damage to the Bluecoat

The next crisis for the Bluecoat begins on 3rd May 1941. It was then that the sustained bombing of Liverpool during World War Two began a fire that spread to the east wings and the central block. MacCunn states that “the north-east wing was completely burnt out and though the walls remained standing the roof and floors collapsed. The south-east wing was destroyed. The roof of the central block collapsed and the concert hall was gutted”. The lower floor of the central block and the staircase approaches, which were “fire proof”, survived with only minor damage. “Two nights later the west side of the Bluecoat Chambers was hit

by a high explosive bomb and the blast and falling debris of bricks and girders did considerable damage to the north end of the west wing”.
